SIX MONTHLY EC COMPLIANCE REPORT FOR THE PERIOD OF APRIL TO SEPTEMBER 2022

Subject: Amendment of Construction of Berth No.4 instead of Berth No.7 at Karaikal Port (Phase-II) at Puducherry by M/s. Karaikal Port Pvt Ltd - Reg

SHORELINE MONITORING STUDY FOR EROSION AND ACCRETION ASSESSMENT AT KARAİKAL PORT FOR THE YEAR 2022

**SHORELINE MONITORING SURVEY
AT KARAİKAL PORT
(JULY 2016)**

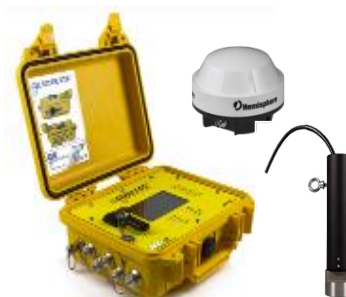
CEESCOPE ECHOSOUNDER: This survey echosounder is manufactured by CEE Hydro systems, Australia. It is a Single frequency echosounder with standard transducer having the frequencies of 200 kHz. It measures the depth ranging between 0 - 200 m with the accuracy of 0.01 m and a resolution of 0.01 m. It has a built in 12 channel GPS receiver with an integrated Beacon receiver. It is a dual channel Beacon receiver for collection of reference station data in both, automatic and manual mode. The system provides horizontal accuracy close to ± 0.5 m. It has the capability of giving position with WGS84 standard datum and 1 user defined datum. It has an antenna with 10 m long cable. The system works on 9 - 18 VDC or on 220 VAC. The unit has two RS232 ports and also Ethernet connection. It is equipped with internal data logger which can store 40 hours survey data and also External USB device for simultaneously log. It also has large LCD display in the front panel operating in touch screen. There is a provision for external DGPS input. It has NMEA output which can be connected to onboard PC and integrated with Hydrographic Software. The touch setting in the front panel enables to mark draught, tide input, time, date, scale shift, calibration gauge, alarm filter and fix interval.

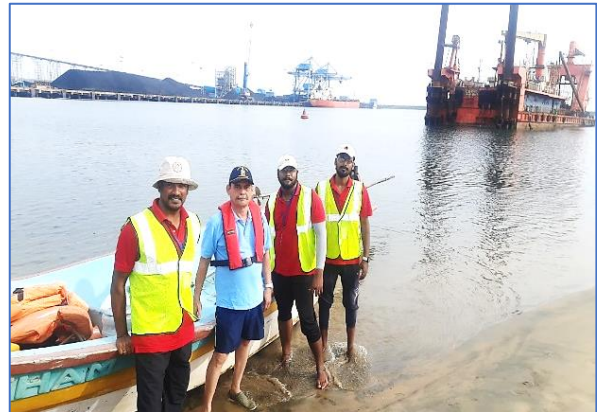
Commencement of bathymetry survey

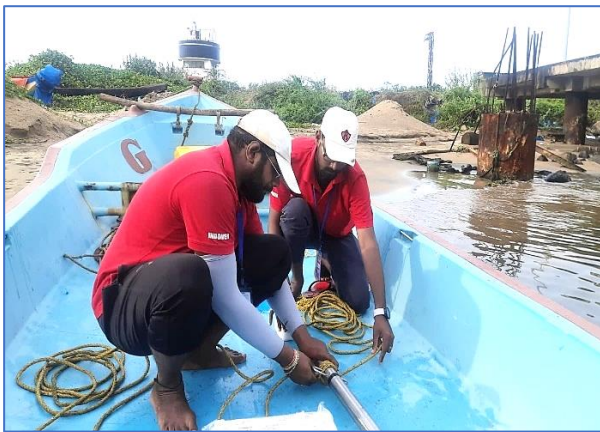
Installation of Transducer

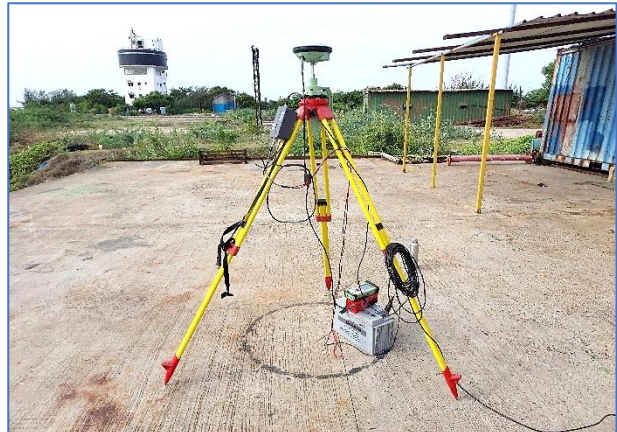
RTK Base station

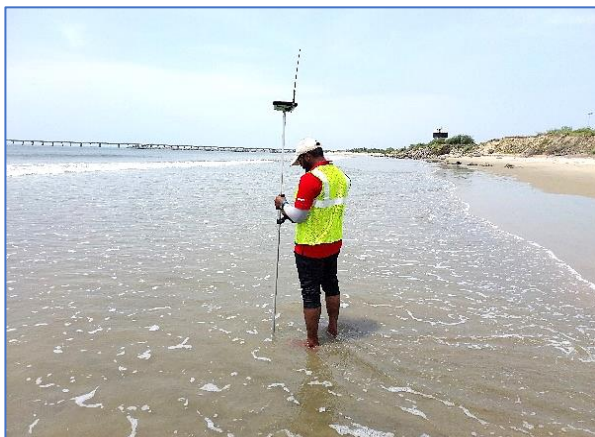
Shoreline survey South side

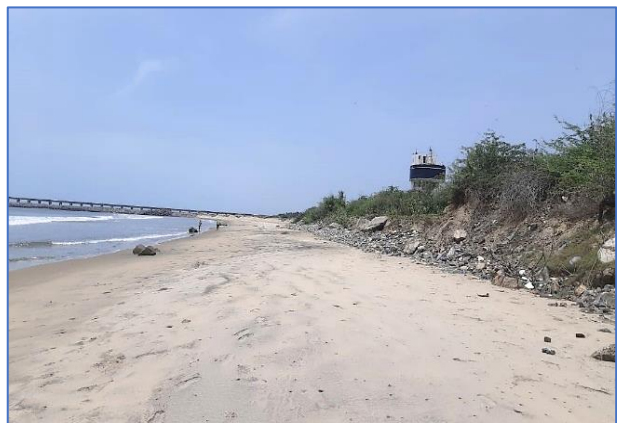
Erosion at south of south breakwater

- Though the southern part of the coastline is expected to be stable, it is suggested to reclaim for 100 m width from High tide line into the sea along the 675 m stretch falling between the Karaikal southern breakwater and Vettar northern breakwater.

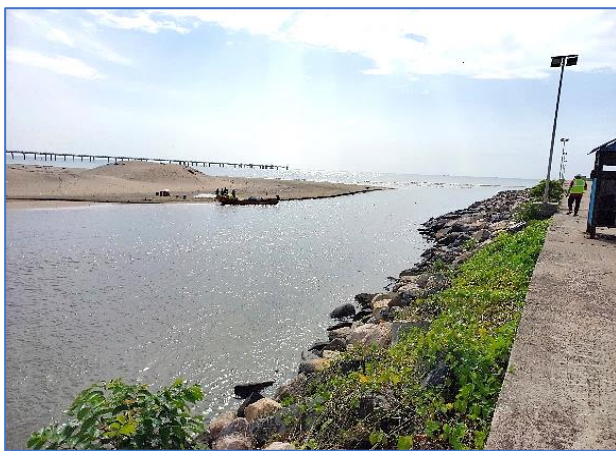
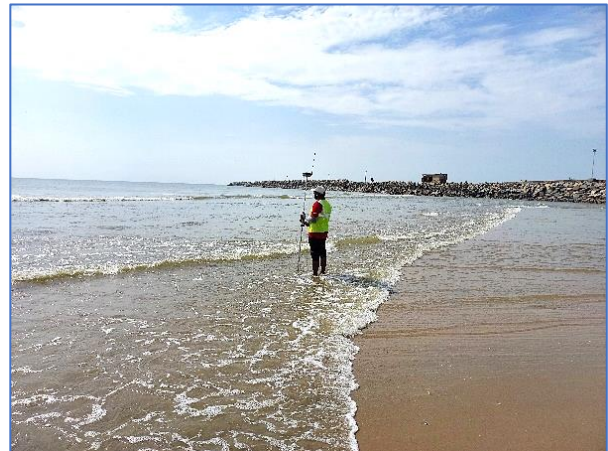
Shoreline survey North side

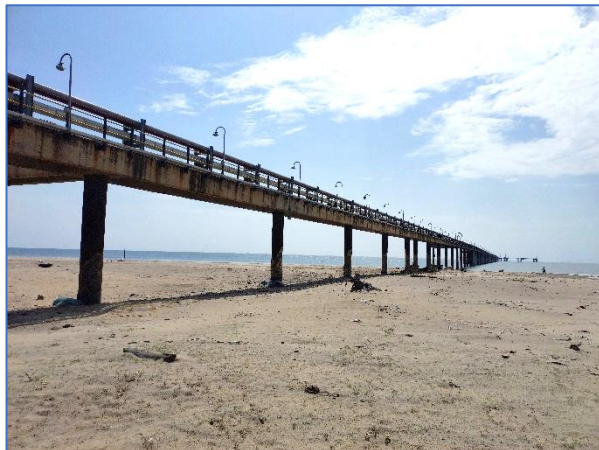
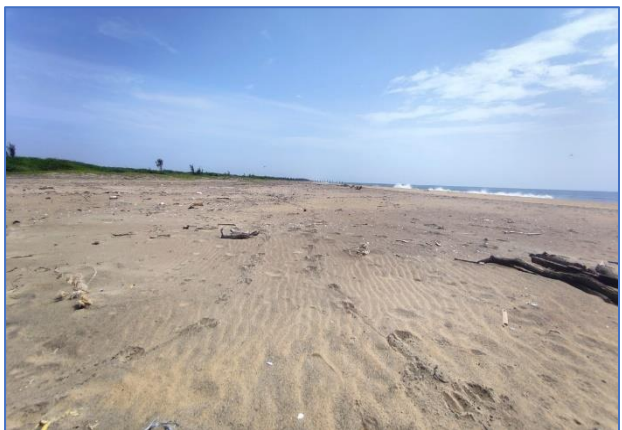
Deposition at north of north breakwater

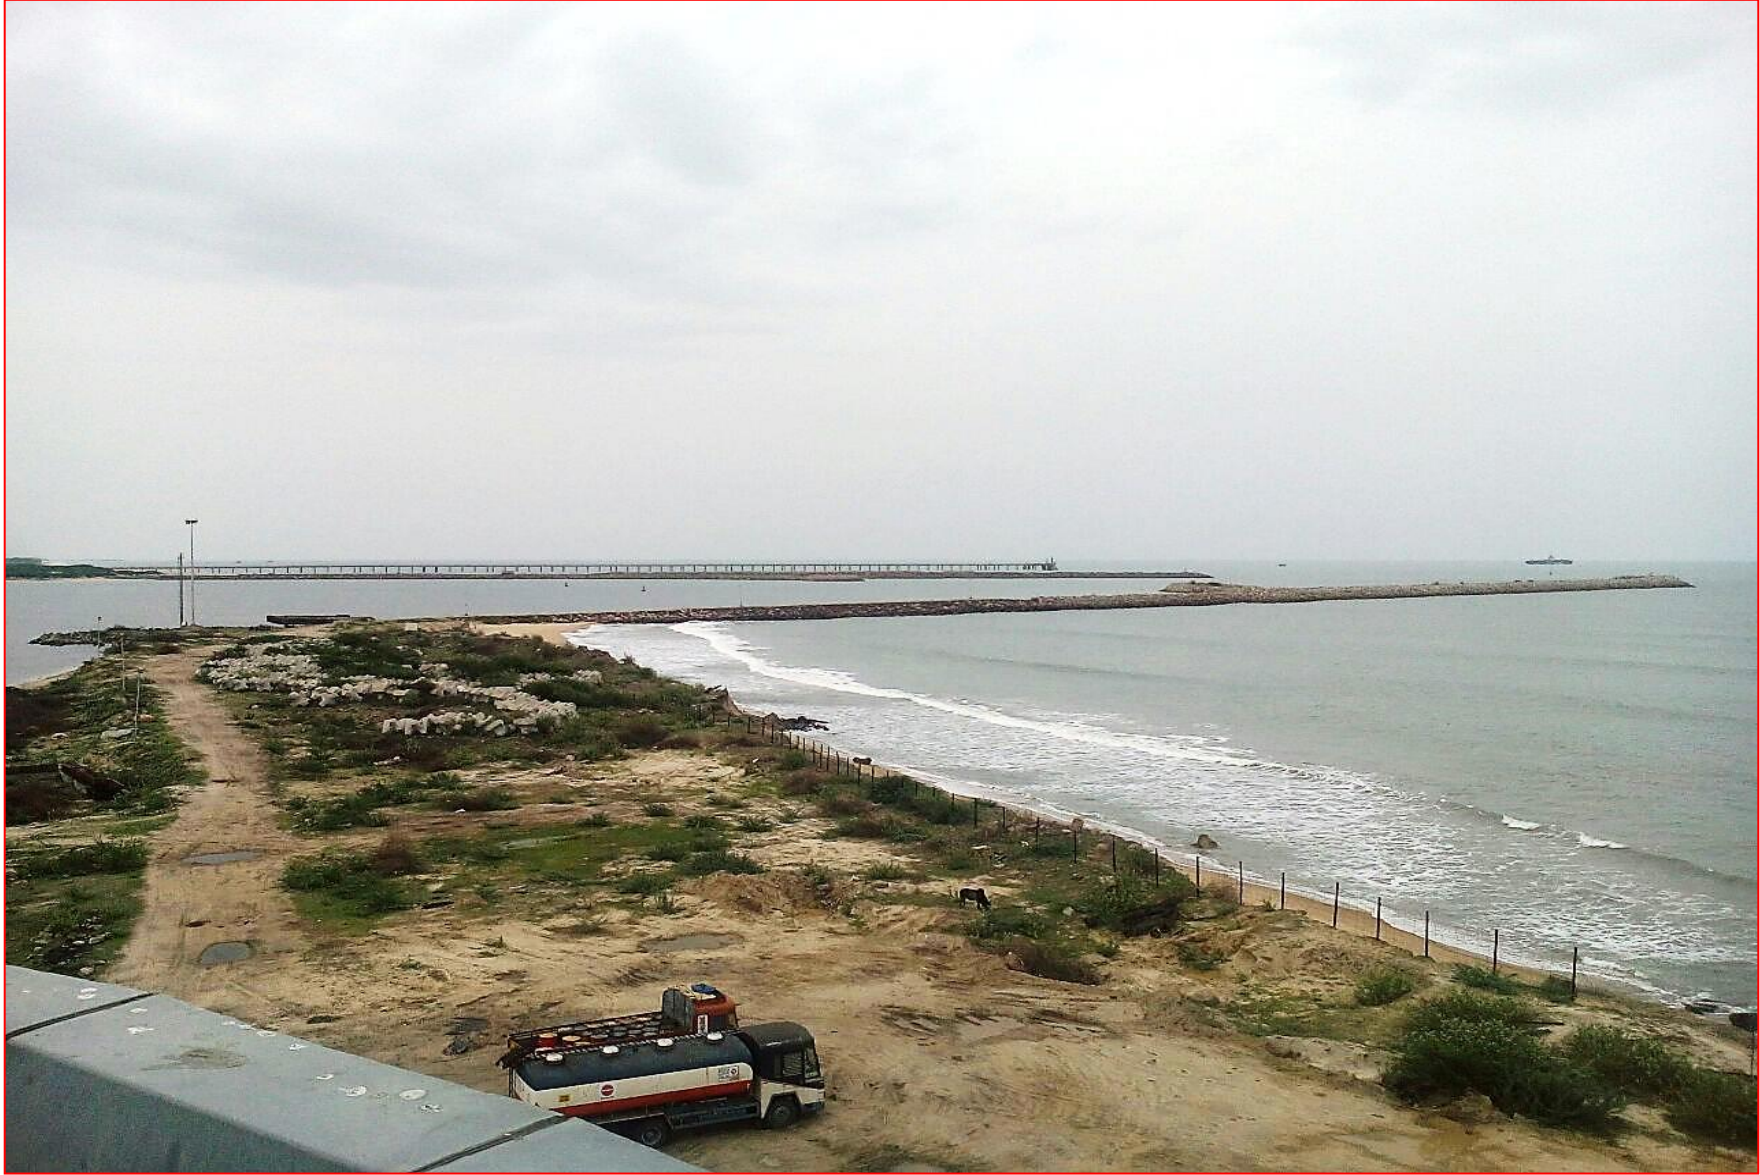
FIG. 2. ALIGNMENT OF TN FISHERIES BREAKWATER IN THE VICINITY OF THE KARAIKAL PORT BREAKWATER

The construction of TN Fisheries breakwaters at Vettar river mouth, particularly its northern breakwater has the influence on the southern part of the shoreline of the Karaikal port. This southern part of coastline is 675 m long stretching between Karaikal port and Vettar river. This segment of 675 m long shoreline has become entrapped and expected to remain stable in future. The alignment of TN Fisheries breakwater in the vicinity of the Karaikal Port breakwater is shown in **Fig. 2**.

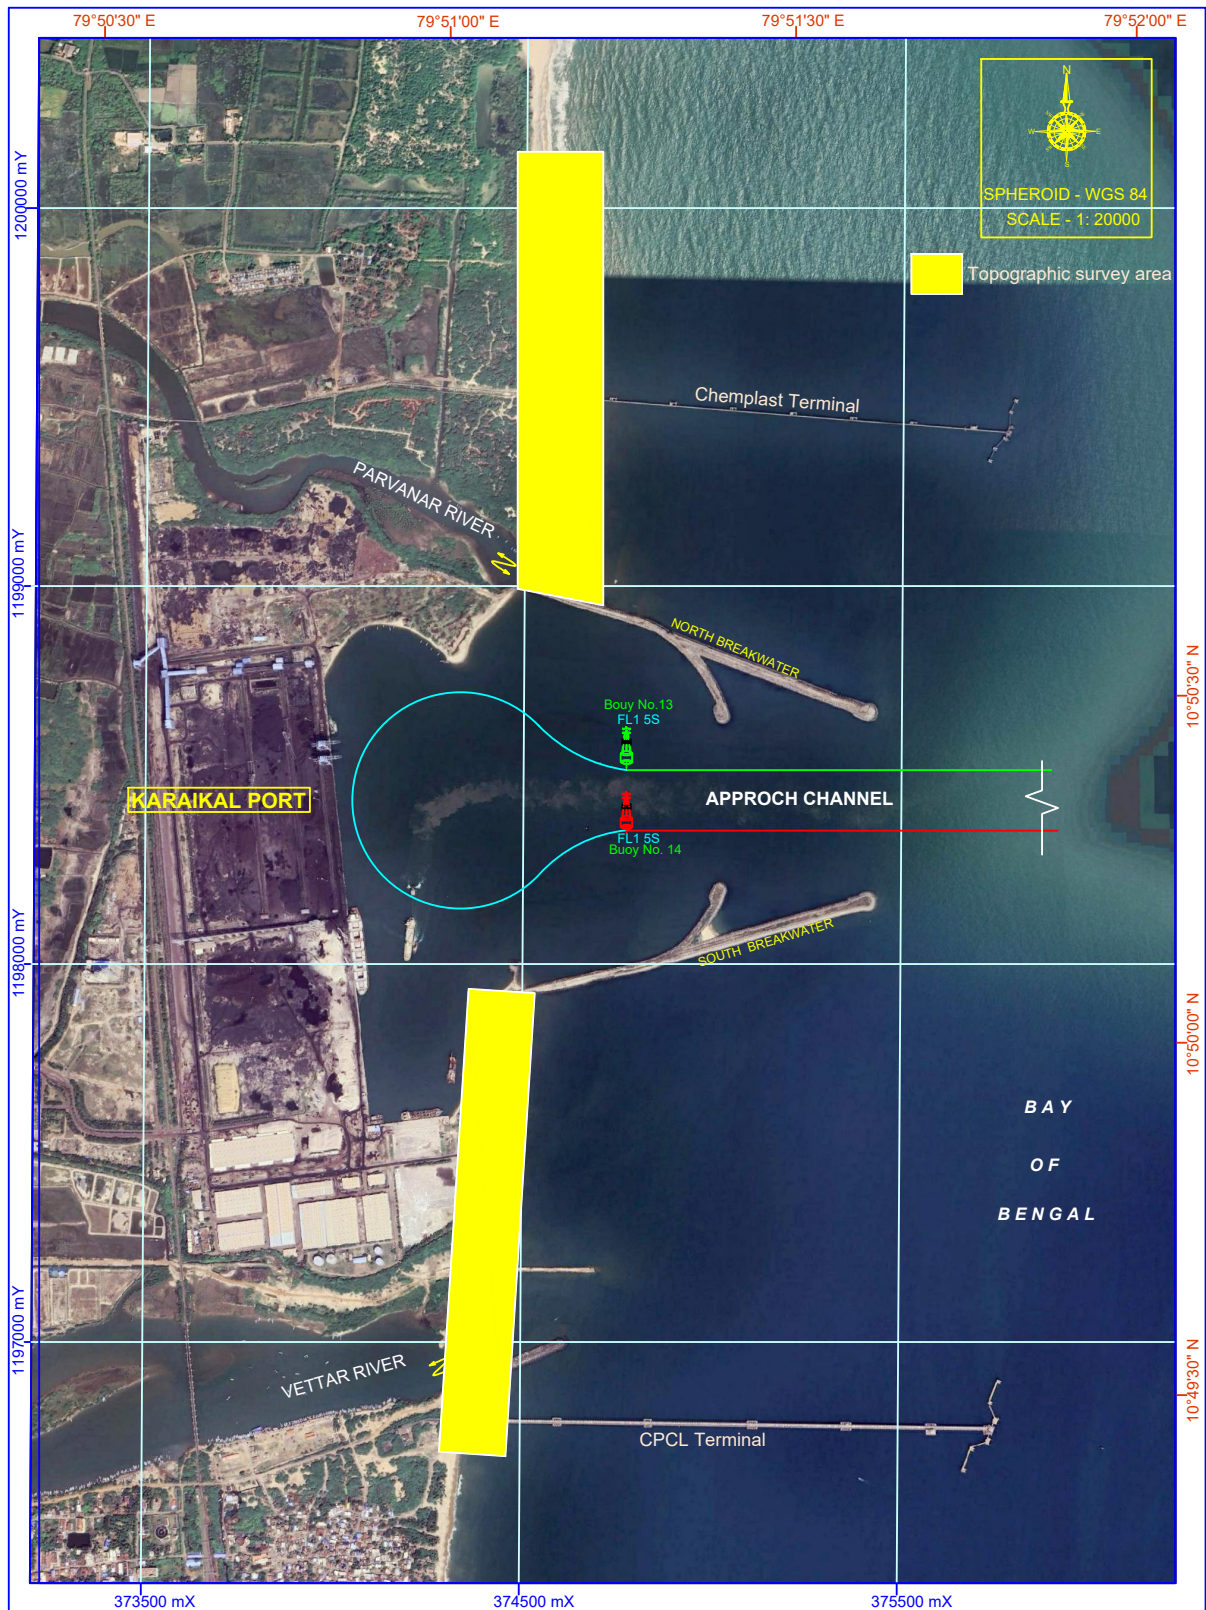
FIG. 3. TOPOGRAPHIC SURVEY AREA

Area of survey: The topographical survey area is shown in **Fig. 3**. The topographical survey was carried out using RTK (Real Time Kinematic) GPS. The topography survey covers either side of the breakwaters 1000 m along the coast and 200 m into the land at 100 m grid interval.

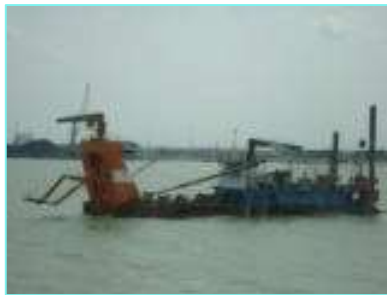
Beach nourishment was carried out in the month of May 2010 and June 2010. The material dredged at offshore was carried and placed on the northern side of the northern breakwater. The quantity of sediment placed for beach nourishment was 16000 m³ in May 2010 and 24000 m³ in June 2010.

Dredging offshore

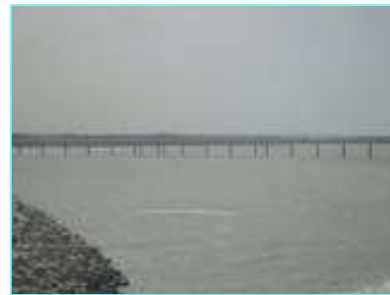
North of NBW

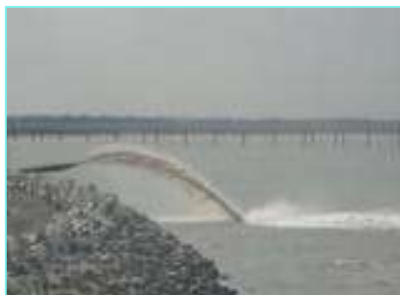
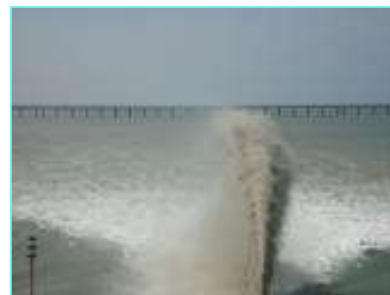
Placement of sediments for beach nourishment

helped to stabilize the shoreline particularly about 600 m distance from the northern breakwater. It is suggested that the same amount of beach nourishment can be carried out from May to July on every year.

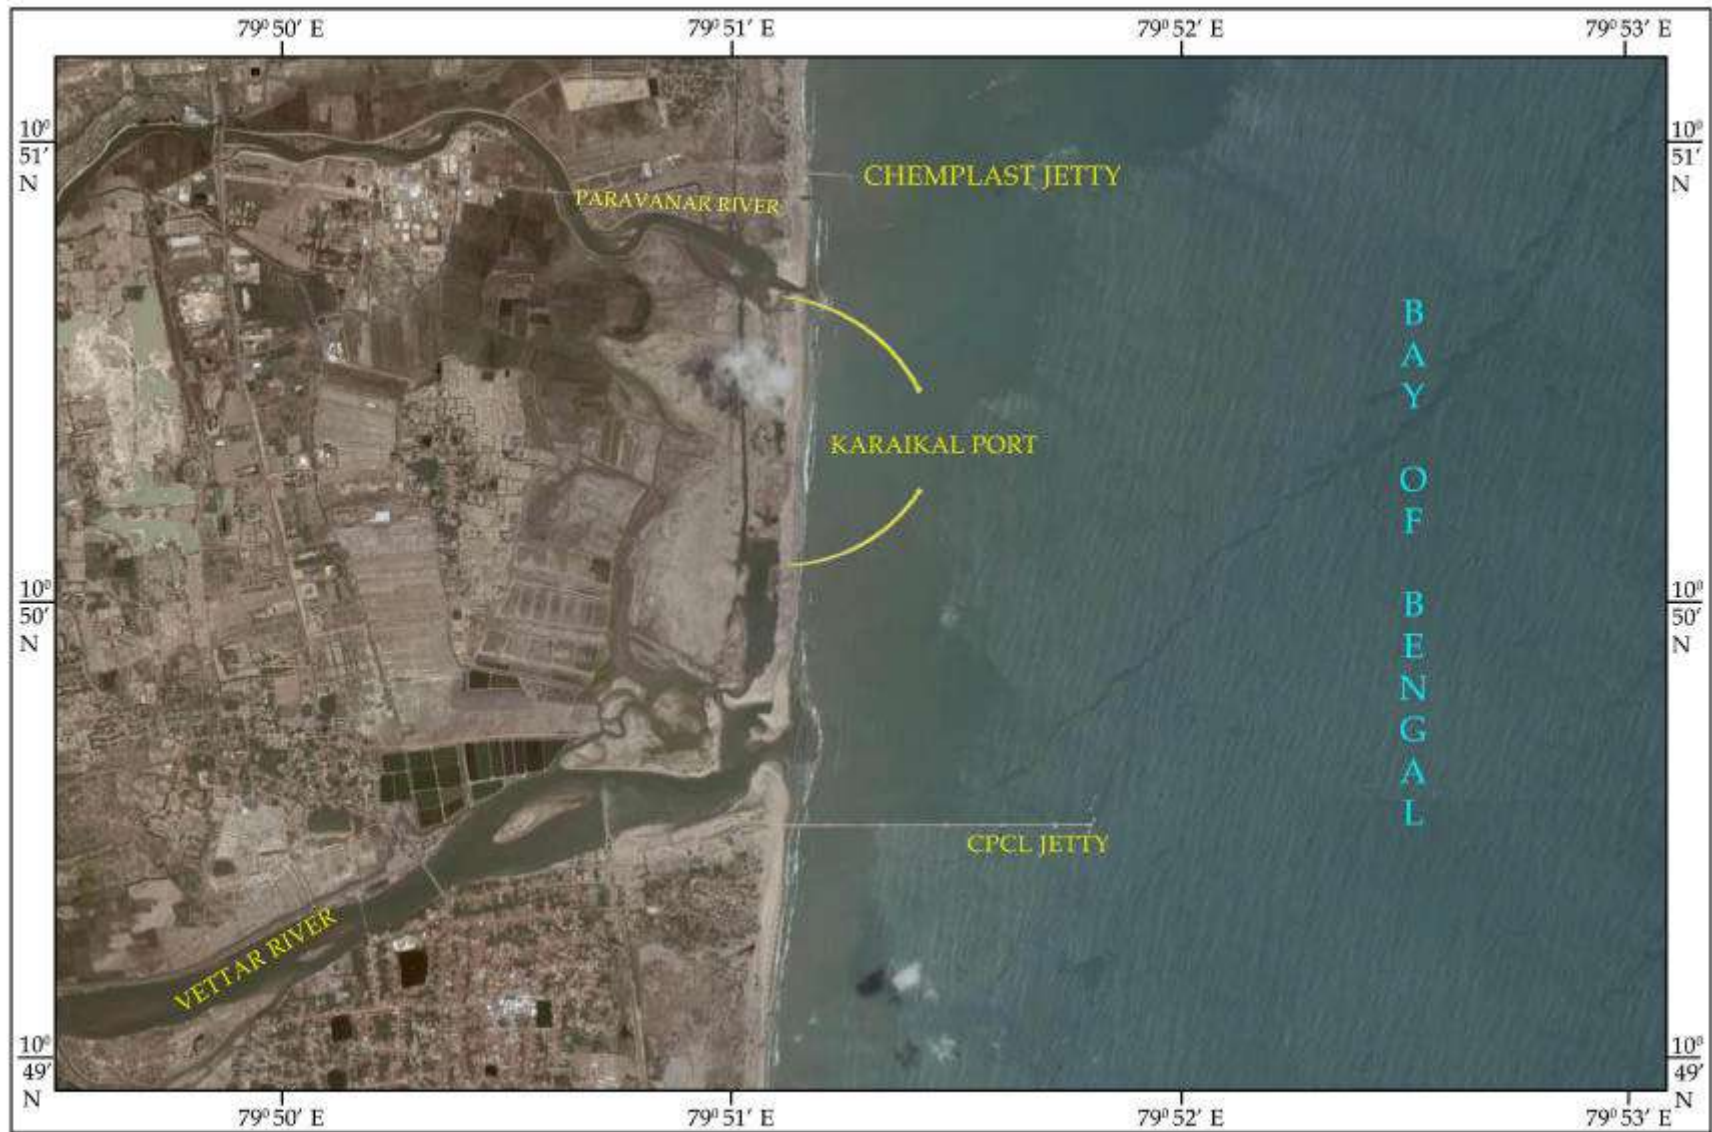
FIG. 2. SATELLITE IMAGERY OF PORT AND COASTLINE IN THE VICINITY

The project locations are shown in Fig. 1 and the satellite imagery is shown in Fig. 2. The neighbouring coastline and the location of 8 reference stations at 200 m spacing covering on either side of the breakwaters are shown in Fig 3. The monitoring area has been divided into 2 zones namely: i) South zone, 600 m long, lying south of the southern breakwater till Vettar River and ii) North zone, 1000 m long, lying on the north of the northern breakwater. The reference points are spaced at 200 m interval and the details are:

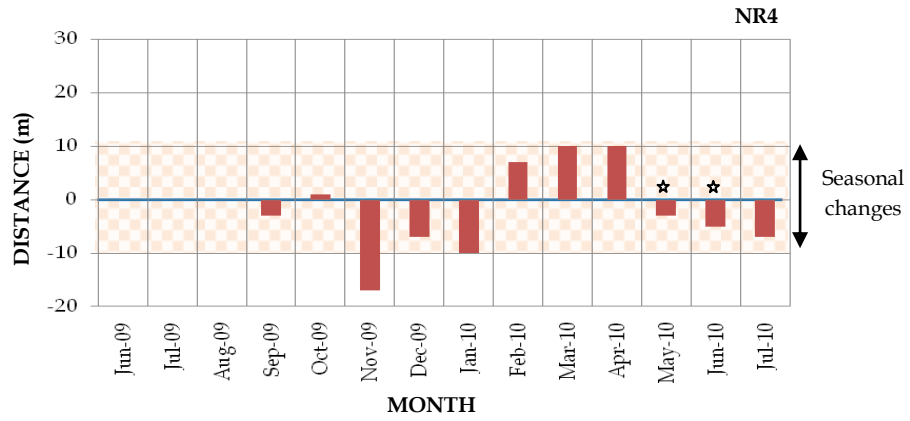
It is important to note that the shoreline will undergo seasonal shifting i.e. about 10 m recession during monsoon and about 10 m accretion during fair weather. Taking into account of the seasonal changes of about 20 m, it is observed that the shoreline changes measured on either side of the breakwaters remain almost stable without any significant erosion or deposition. The beach nourishment carried out in May 2010 and June 2010

Fig. 4. Shoreline changes from June 2009 to July 2010 (NR1 to NR5)

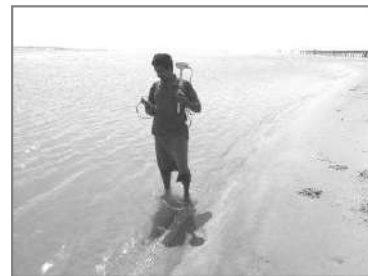
The coastline form has been surveyed using **Hemisphere R100 Series DGPS Beacon Receiver**.

It combines high-performance GPS reception with a DGPS-capable receiver in a lightweight, durable housing and comes with a separate antenna. It

gives the horizontal position to an accuracy of close to 1 m. The GPS receiver also contains technology enabling *WAAS/EGNOS*, *OmniSTAR* or *Beacon* real time differential capabilities. When used with a Real-time Kinematic (RTK) Base station, the GPS receiver provides RTK positioning for high-accuracy, centimeter-level applications. A standard GPS receiver provides the following features: •10 Hz (10 positions per second) output rate •12 GPS (C/A-code L1,C/A code L2 (for the OmniSTAR XP/HP and RTK models)) tracking channels, code carrier channels •Sub meter differential accuracy (RMS), assuming at least five satellites and a PDOP (Position Dilution of Precision) of less than four (when used with Satellite Based Augmentation Systems (SBAS) correction).
